# 2002 Annual Compliance Report Lakeview, Oregon, Disposal Site

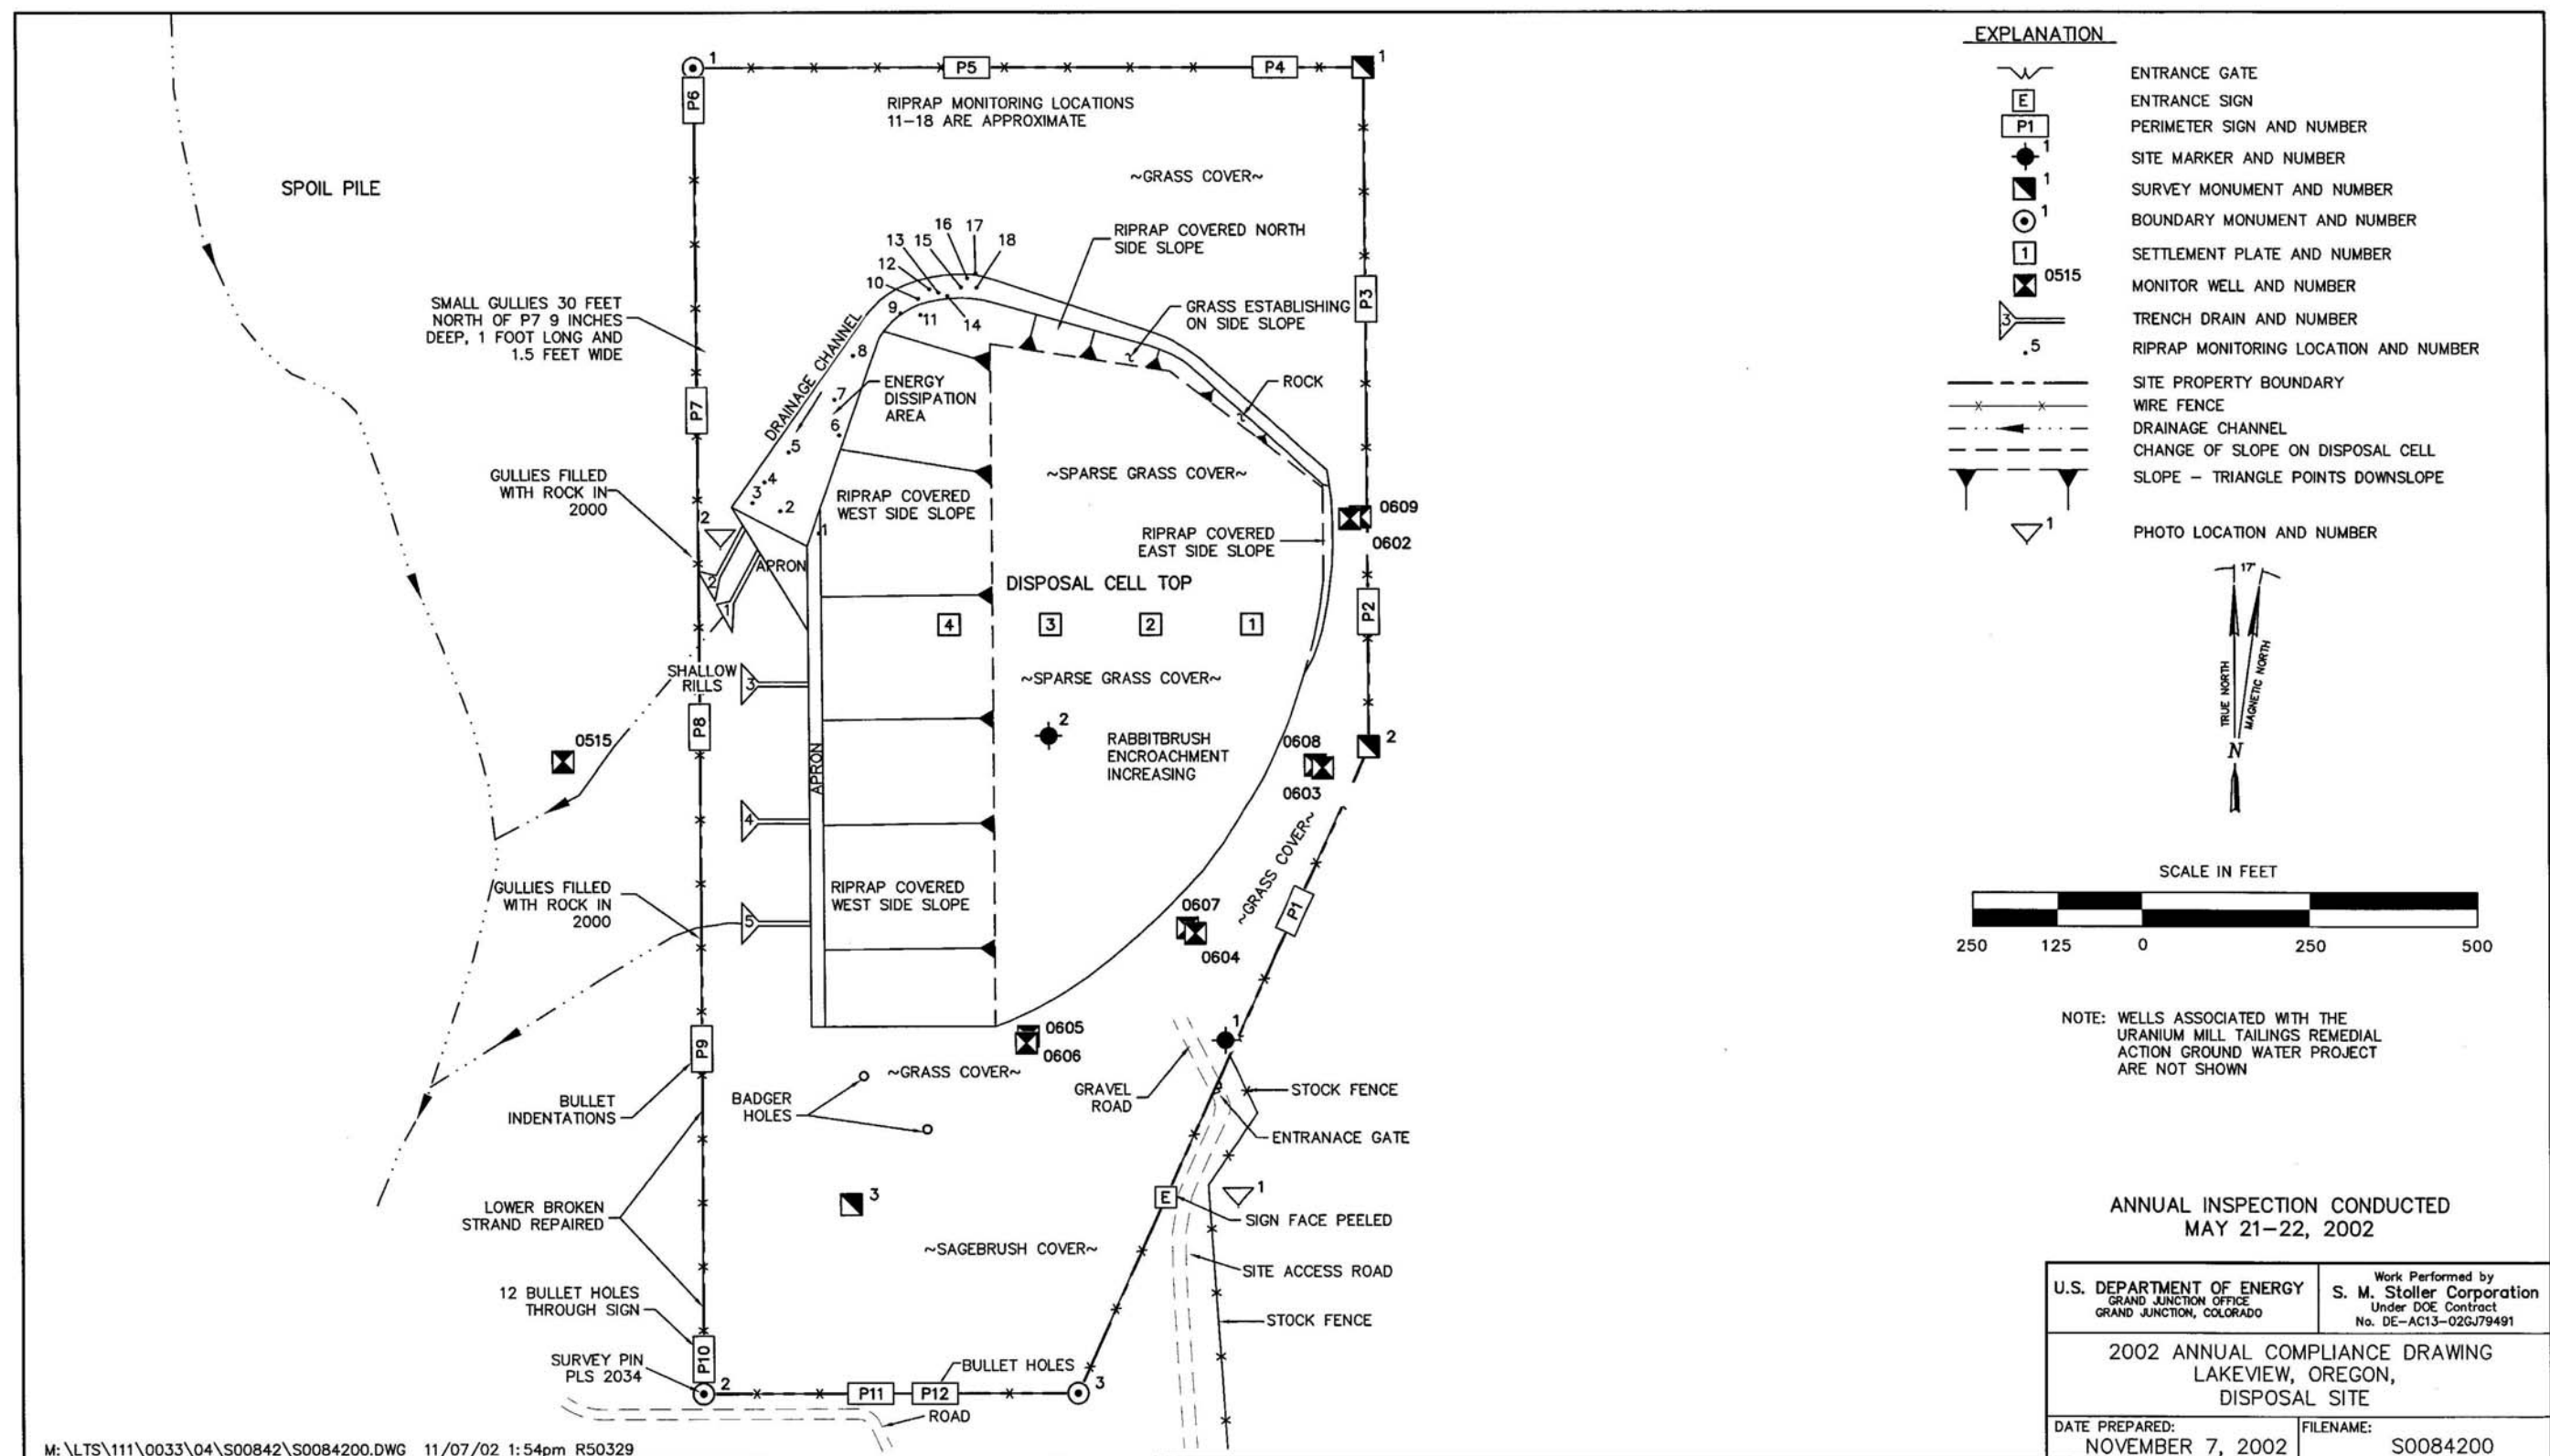
Figure 9-1. 2002 Annual Compliance Drawing for the Lakeview, Oregon, Disposal Site

The site, northwest of Lakeview, Oregon, was inspected on May 21 and 22, 2002. Results of the inspection are described below. Features and the photograph locations (PLs) mentioned in this report are shown on Figure 9-1. Numbers in the left margin of this report refer to items summarized in the Executive Summary table.

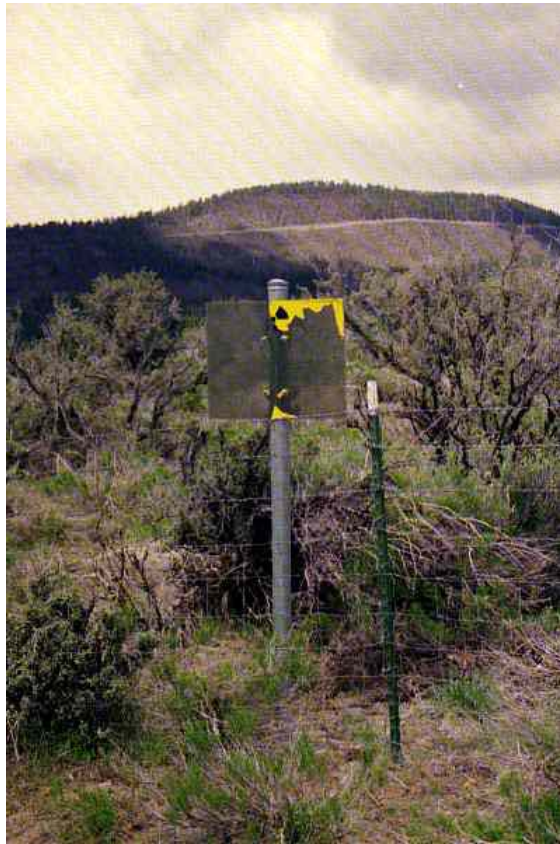
9C The painted surface of the entrance sign had peeled away and the sign was illegible (PL–1). As a temporary measure, inspectors wrote the Grand Junction Office contact telephone number on the entrance sign; the sign was later replaced. Nine of the twelve perimeter signs were in good condition. Perimeter signs P9, P10, and P12 have been damaged by bullets; however they were still legible so replacement is not yet warranted.

*PL-1. Unreadable entrance sign.*

DOE replaced the entrance sign, performed minor fence repairs, and repainted some rock monitoring identification numbers in 2002.

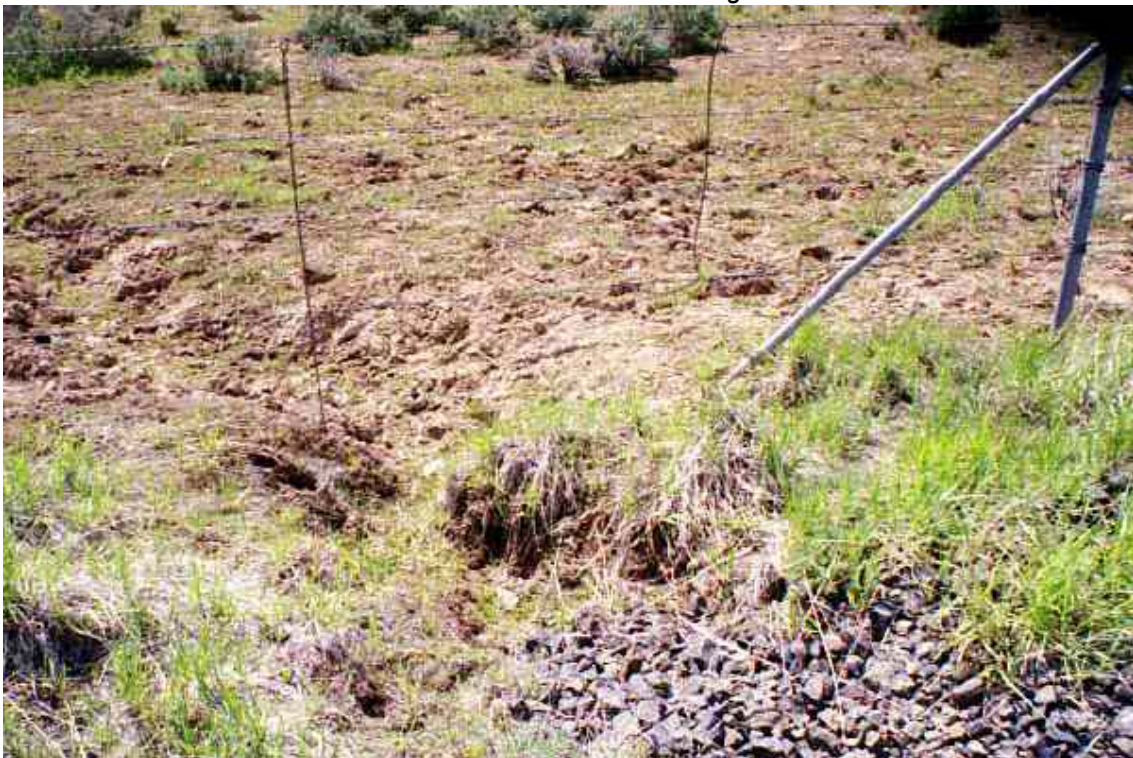
**Site Perimeter and Outlying Area**—Gullies that formed in seeded areas extending west of Trench Drains 1, 2, 3, 4, and 5 were filled with rock in 2000. The rock has nearly arrested the headcutting that was proceeding from the Collins Ranch property onto the DOE property (PL-2). The headcuts, if allowed to grow, could enable cattle to enter the site. There was no evidence of livestock on the site.

*PL-2. Headcutting under west boundary fence.*
